Dentistry Clinical

Engineering the solution

Harry Shiers presents a case report on the restoration of a unilateral posterior maxilla with an implant-retained bridge

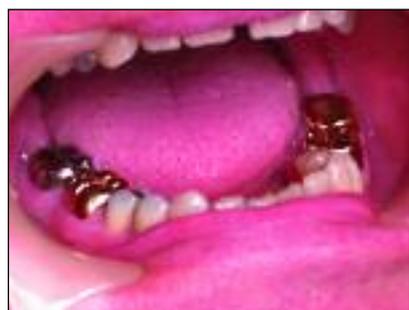
Figure 1: The patient demonstrated fairly heavily restored dentition

On examination, the patient demonstrated a fairly heavily restored dentition with one metal ceramic crown and five amalgam restorations in the maxilla and four gold crowns, (two of these teeth root treated) and three further restorations in the mandible (Figure 1). The most extensive restorative work was in the posterior segments and there was evidence on the teeth of a bruxing habit.

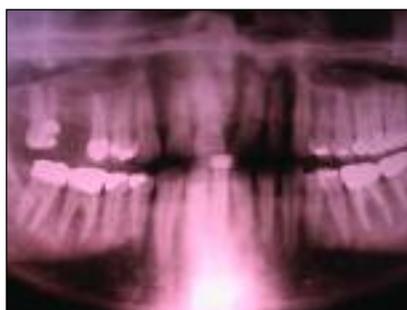
Figure 2: The DPT of the patient at presentation. The periapical radiolucency associated with the mesio-buccal and palatal roots may be seen

Figure 2 shows the DPT of the patient at presentation. The periapical radiolucency associated with the mesio-buccal and palatal roots may be seen. Figure 3 shows a digital periapical image of the upper

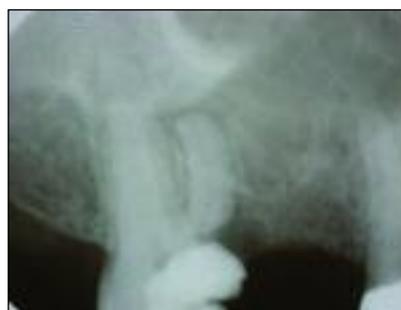
Figure 3: A digital periapical image of the upper right second molar and upper right second pre-molar, where the extent of the decay in the maxillary second molar is seen more clearly

right second molar and upper right second pre-molar, where the extent of the decay in the maxillary second molar is seen more clearly.

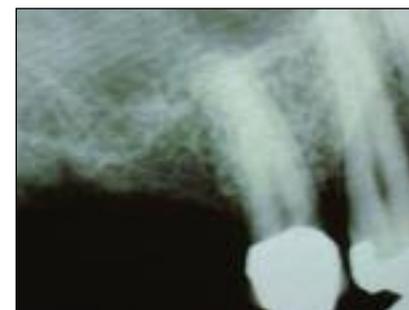
Figure 4: Two further periapical radiographs were taken prior to the selection of the implants

and luxators. The patient was reviewed one week later and healing had been uneventful. A pre-operative appointment was made for the end of March when two further periapical radiographs were taken prior to the selection of the implants (Figure 4).

Two Astra Osseospeed implants were selected – a 5.0mm diameter for the most posterior site and a 4.0mm diameter for the anterior site. A two-stage surgical procedure was planned, and surgical placement of the implants was carried out at the beginning of April 2005.

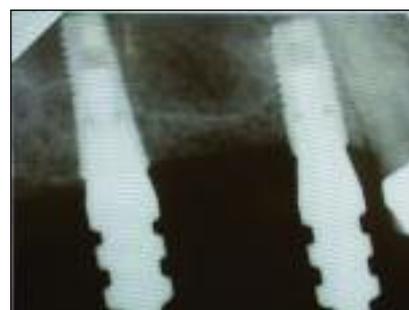
Figure 5: The impression copings in

The second stage surgery was performed two and a half months after implant placement. Head-of-implant impressions followed this three weeks later. Figure 5 shows the impression copings in situ. Once the model had been cast with the appropriate replicas, two 20-degree taper uni-abutments were selected for construction of a screw-retained bridge (Figure 6). Figure 7 demonstrates the implant-retained bridge on the model.

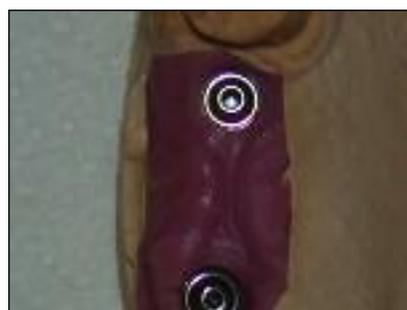
Figure 6: Uni-abutments were selected for construction of a screw-retained bridge

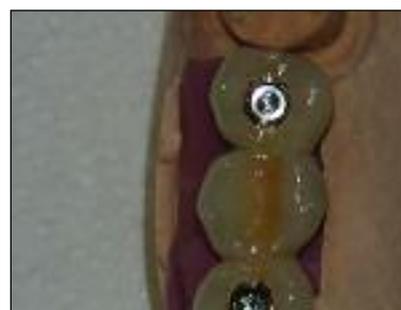
Figure 7: The implant-retained bridge

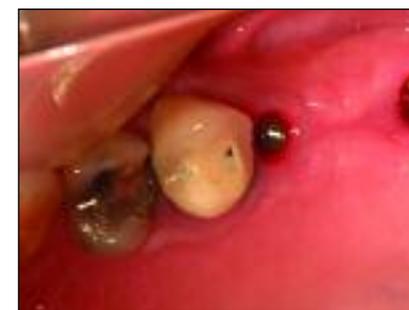
Figure 8: Two new uni-abutments were fitted

The next appointment was the fit stage, where two new uni-abutments were fitted (Figure 8) and the bridge attached with two bridge screws, the screw heads covered with cotton wool and the screw hole filled with

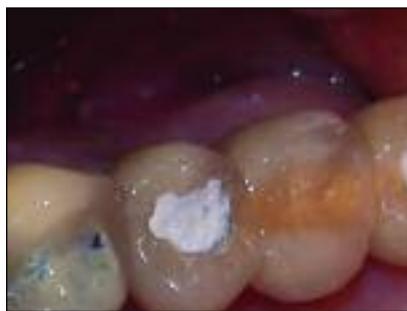
Figure 9: The bridge attached with temporary restorative material covering the screw heads. Figure 10: An anteroposterior radiograph was taken of the implants at fit stage and the occlusion examined and adjusted using Schimstock as the indicator.

a temporary restorative material (Figure 9). An anteroposterior (AP) radiograph was taken of the implants at fit stage (Figure 10) and the occlusion examined and adjusted, using Schimstock as the indicator.

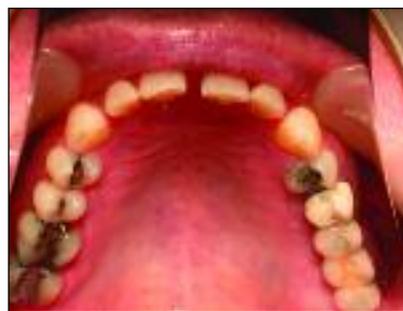
Figure 11: The temporary restorative material was replaced with composite. Figure 12: The bridge in centric relation from the buccal aspect.

The patient was reviewed at two weeks and three months, at the latter appointment the cotton wool and temporary restorative were changed and the temporary restorative replaced with composite (Figure 11). Figure 12 shows the bridge in centric relation from the buccal aspect. Figures 13 to 16 show radiographs at intervals up to March 2009.

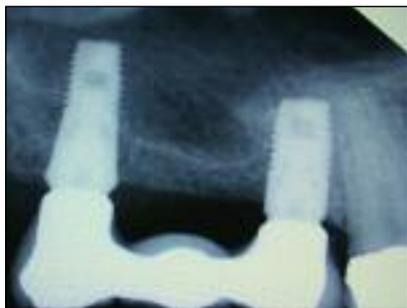
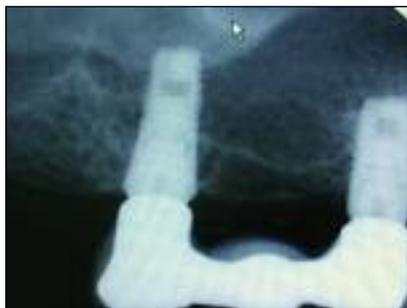
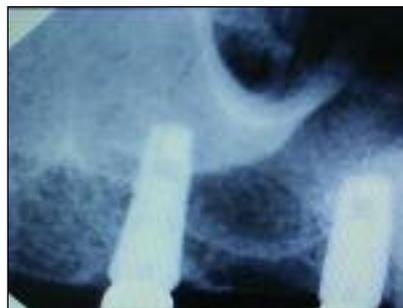
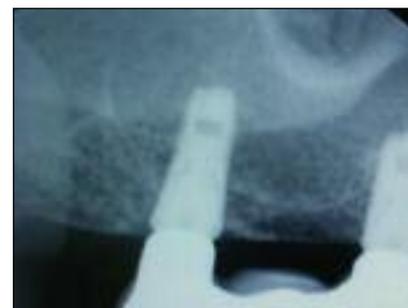
Figures 13-16: Radiographs at intervals up to March 2009.
